Lead Based Paint Dust Wipe Analysis Dust Hazard Mitigation Plan and Lead Inspection Report Risk Assessment (preliminary phase)

**195 McGregor Street,
Manchester, NH 03102**

Residential Report

**American Environmental Testing Services, LLC
1 Hardy Road, Suite #218 Bedford, NH 03110**

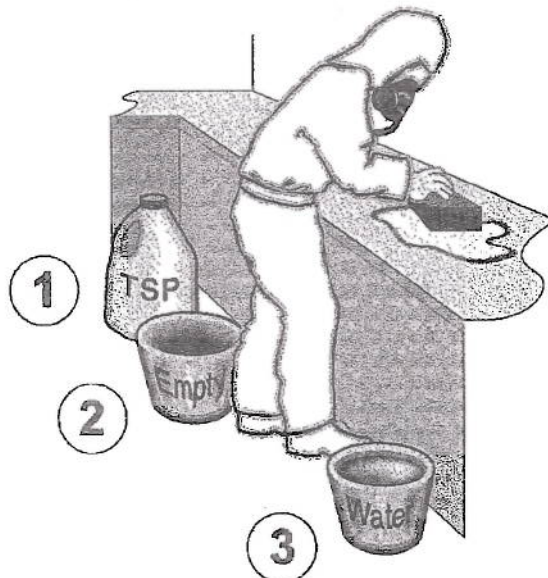
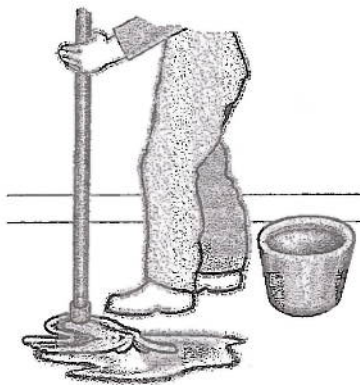
Figure 14.4c (continued)

Wash all surfaces with suitable detergents

Wash *all surfaces* in the work area with suitable detergents, including areas that had been covered with plastic. Some wallpaper should only be HEPA vacuumed, since it may be damaged by the detergent.

**Wipe All Surfaces**

**Wet Mop Floor**

**Don't Dry Sweep**
